Mount Zion Church Northeast Wall Stabilization Assessment Report

Report to Loudoun County Parks and Recreation
June 15, 2006

Produced by The John Greenwalt Lee Company

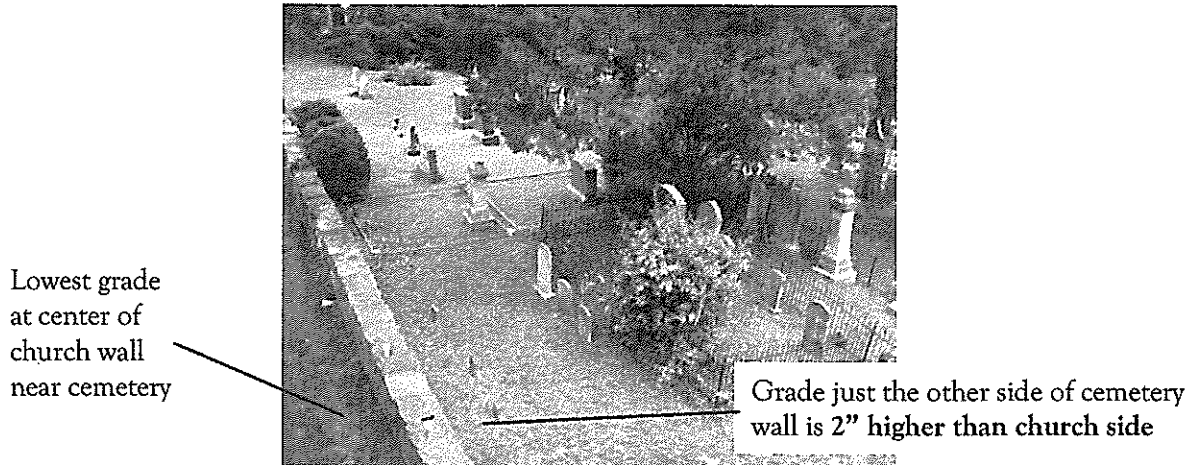
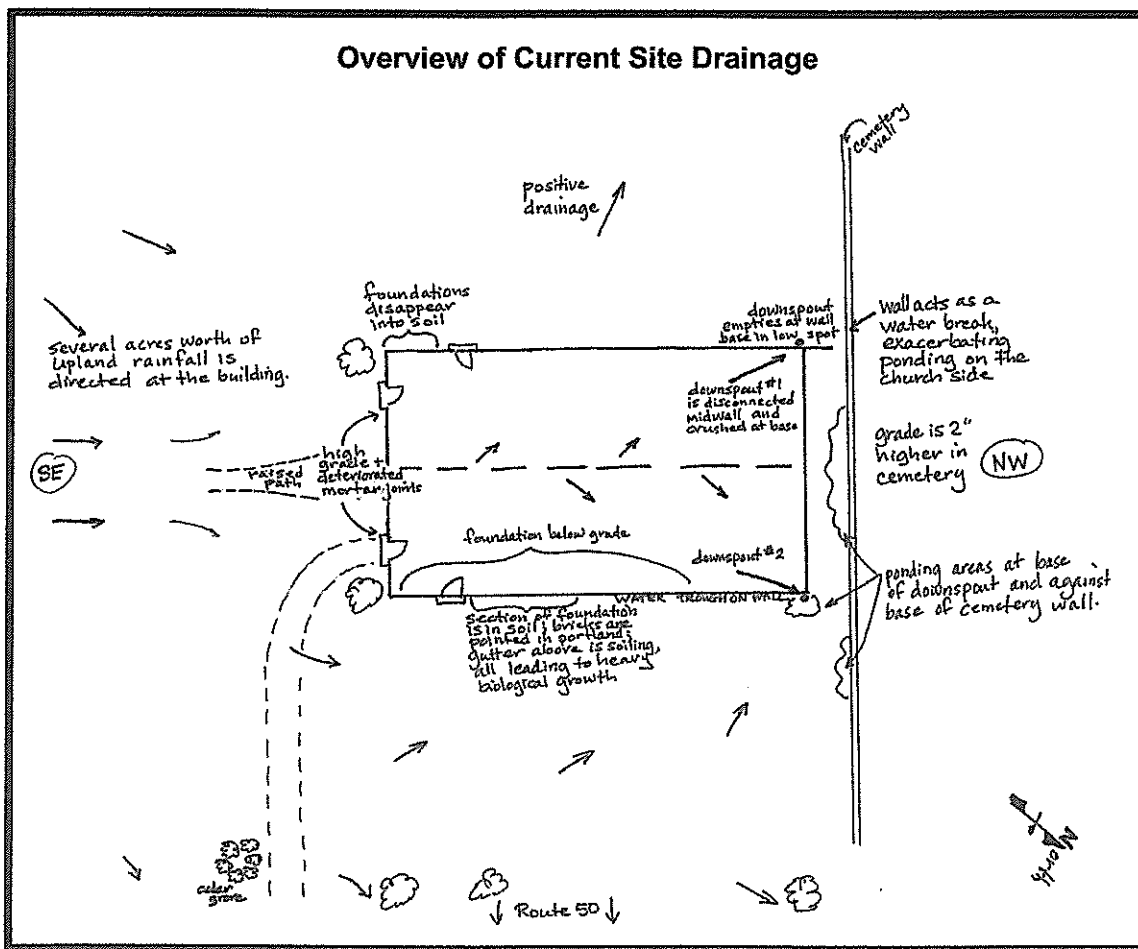
Downspout empties into a ground depression at North corner of building

The cemetery wall acts as a barrier, trapping water against the base of the NW wall. This coincides with being one of the lowest drainage points in the grade. Most of the church property is already draining toward this location from the South.
